## SITES AND FIBERS BEING DELIVERED.

The last few weeks the SUNET network rollout-team has been very busy driving around Sweden, we have received delivery-confirmations on a lot of sites and fibers from our suppliers and we want to be first on site to inspect and perform OTDR-measurements on delivered fibers. There is a prerequisite from the tender that every fiber delivered to us should come with a complete bi-directional OTDR-measurement before being accepted in production. We have these already since a year back, and to follow-up on this we did a few unannounced sample-test of both OTDR-measurements and how the actual sites looks and the results was not living up to our high demands. This made us take the decision of sending teams around and go and visit every site and inspect every fiber that is built for us before we accept them as finalized and delivered from our vendor. With 100+ sites and multiple fibers going out from every site, it's quite a hefty job. Luckily the sites and optical paths is delivered in batches so we can tick them off one by one.

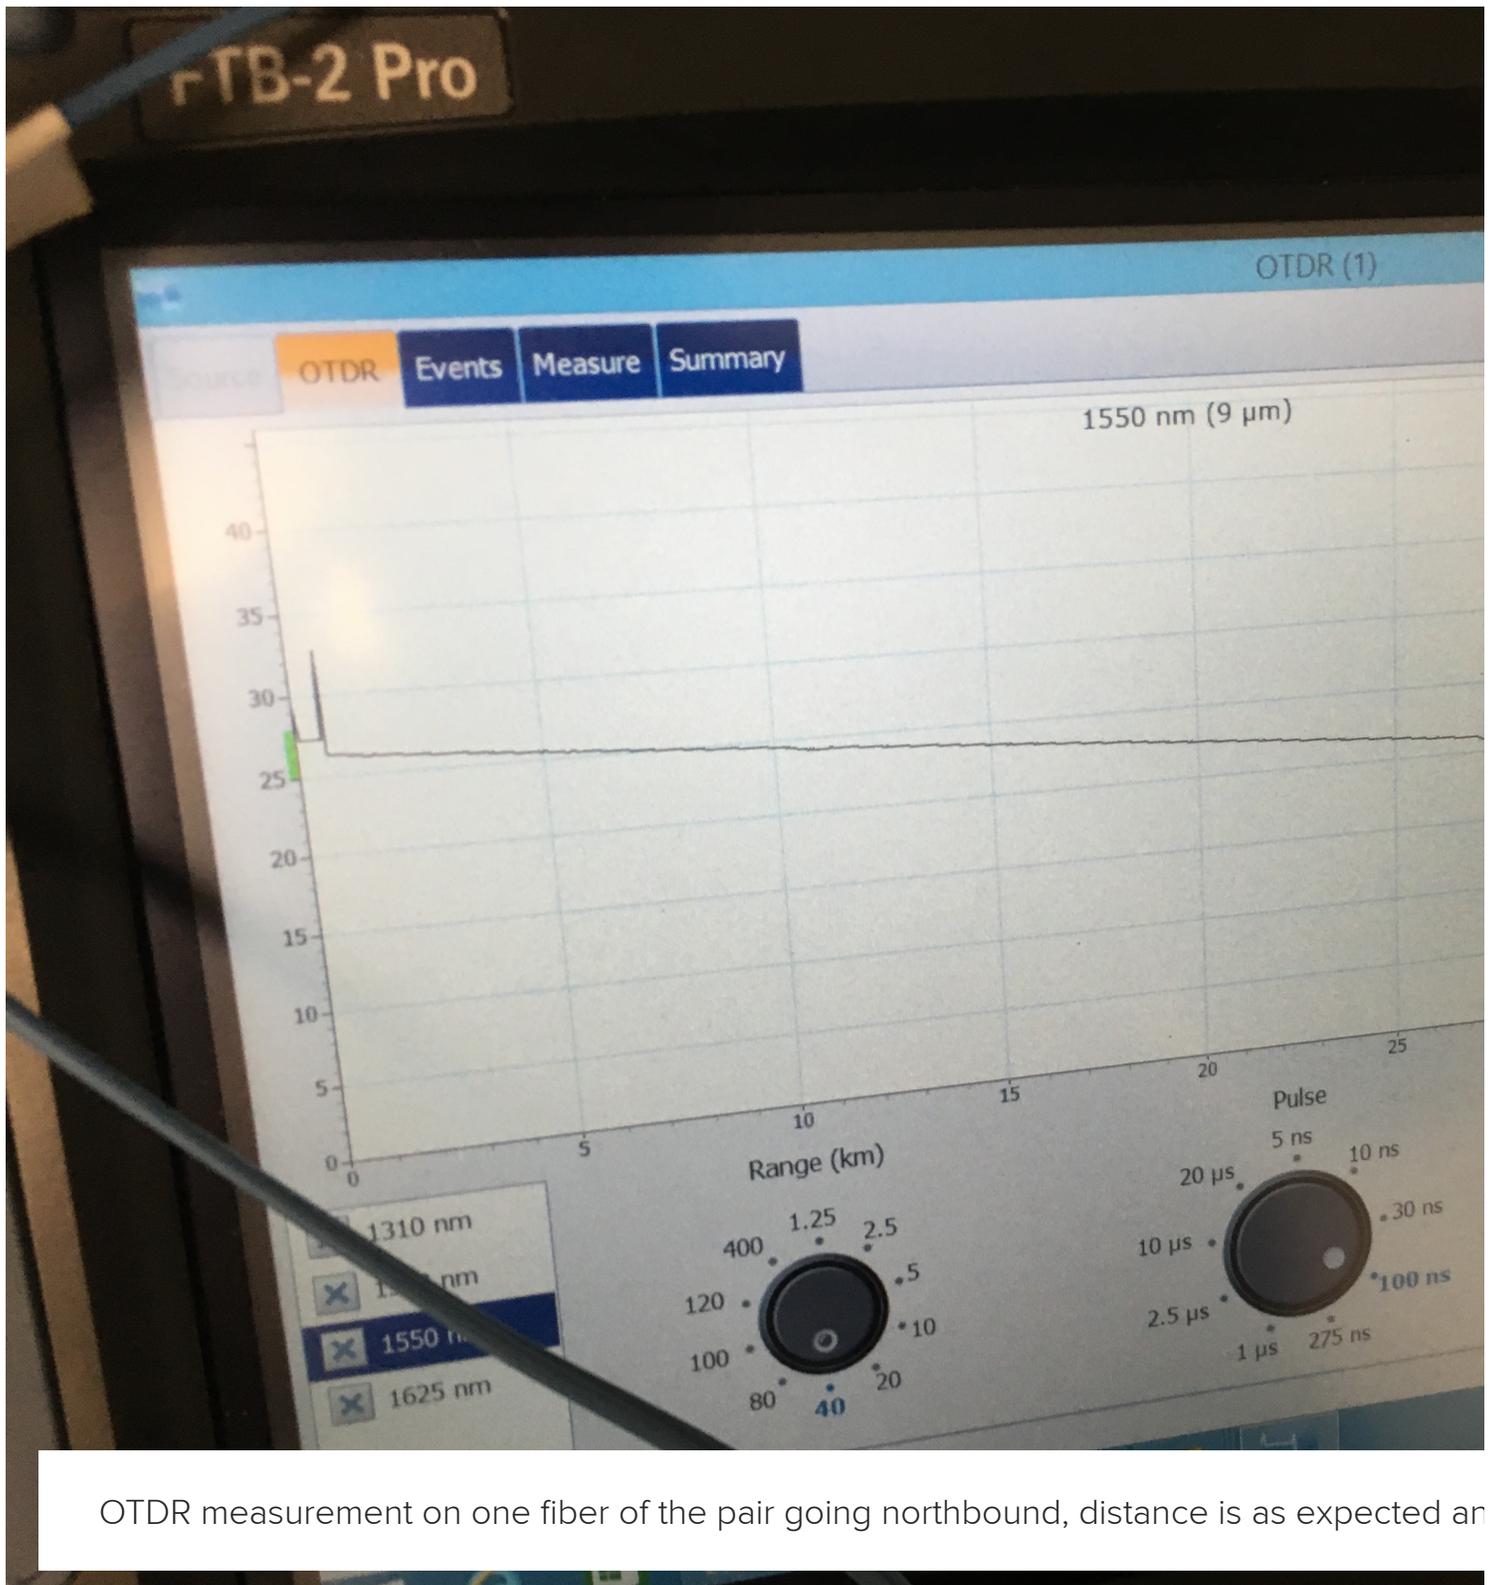
OTDR measurement on one fiber of the pair going northbound, distance is as expected and

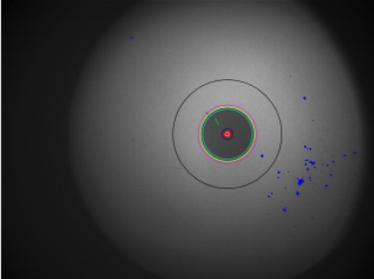
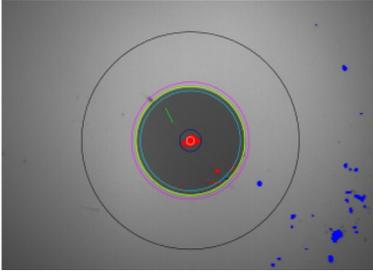
Below is a microscopic-view inside of the RX-side of a amplifier (remember that RAMAN pumps light in the RX-direction). Here someone has plugged in a fiber and managed to get some dirt inside or it was like this when coming from the factory, we dont

know. This resulted in a permanent etch in the amplifier which caused a 10dB loss.. Amplifier accepted as DOA by vendor ADVA.

Zone	Defects	Scratches
Zone A (0 - 25)	FAIL	PASS
Zone B (25 - 115)	FAIL	PASS
Zone C (115 - 135)	PASS	PASS
Zone D (135 - 250)	PASS	PASS

Zone A: [DEFECTS] More than 0 defects.

Zone B: [DEFECTS] Defect > 5 μm, More than 5 defects > 2,0 μm in diameter.

Uncleanable etch on a amplifier.
