## SITES AND FIBERS BEING DELIVERED.

The last few weeks the SUNET network rollout-team has been very busy driving around Sweden, we have received delivery-confirmations on a lot of sites and fibers from our suppliers and we want to be first on site to inspect and perform OTDR-measurements on delivered fibers. There is a prerequisite from the tender that every fiber delivered to us should come with a complete bi-directional OTDR-measurement before being accepted in production. We have these already since a year back, and to follow-up on this we did a few unannounced sample-test of both OTDR-measurements and how the actual sites looks and the results was not living up to our high demands. This made us take the decision of sending teams around and go and visit every site and inspect every fiber that is built for us before we accept them as finalized and delivered from our vendor. With 100+ sites and multiple fibers going out from every site, it's quite a hefty job. Luckily the sites and optical paths is delivered in batches so we can tick them off one by one.

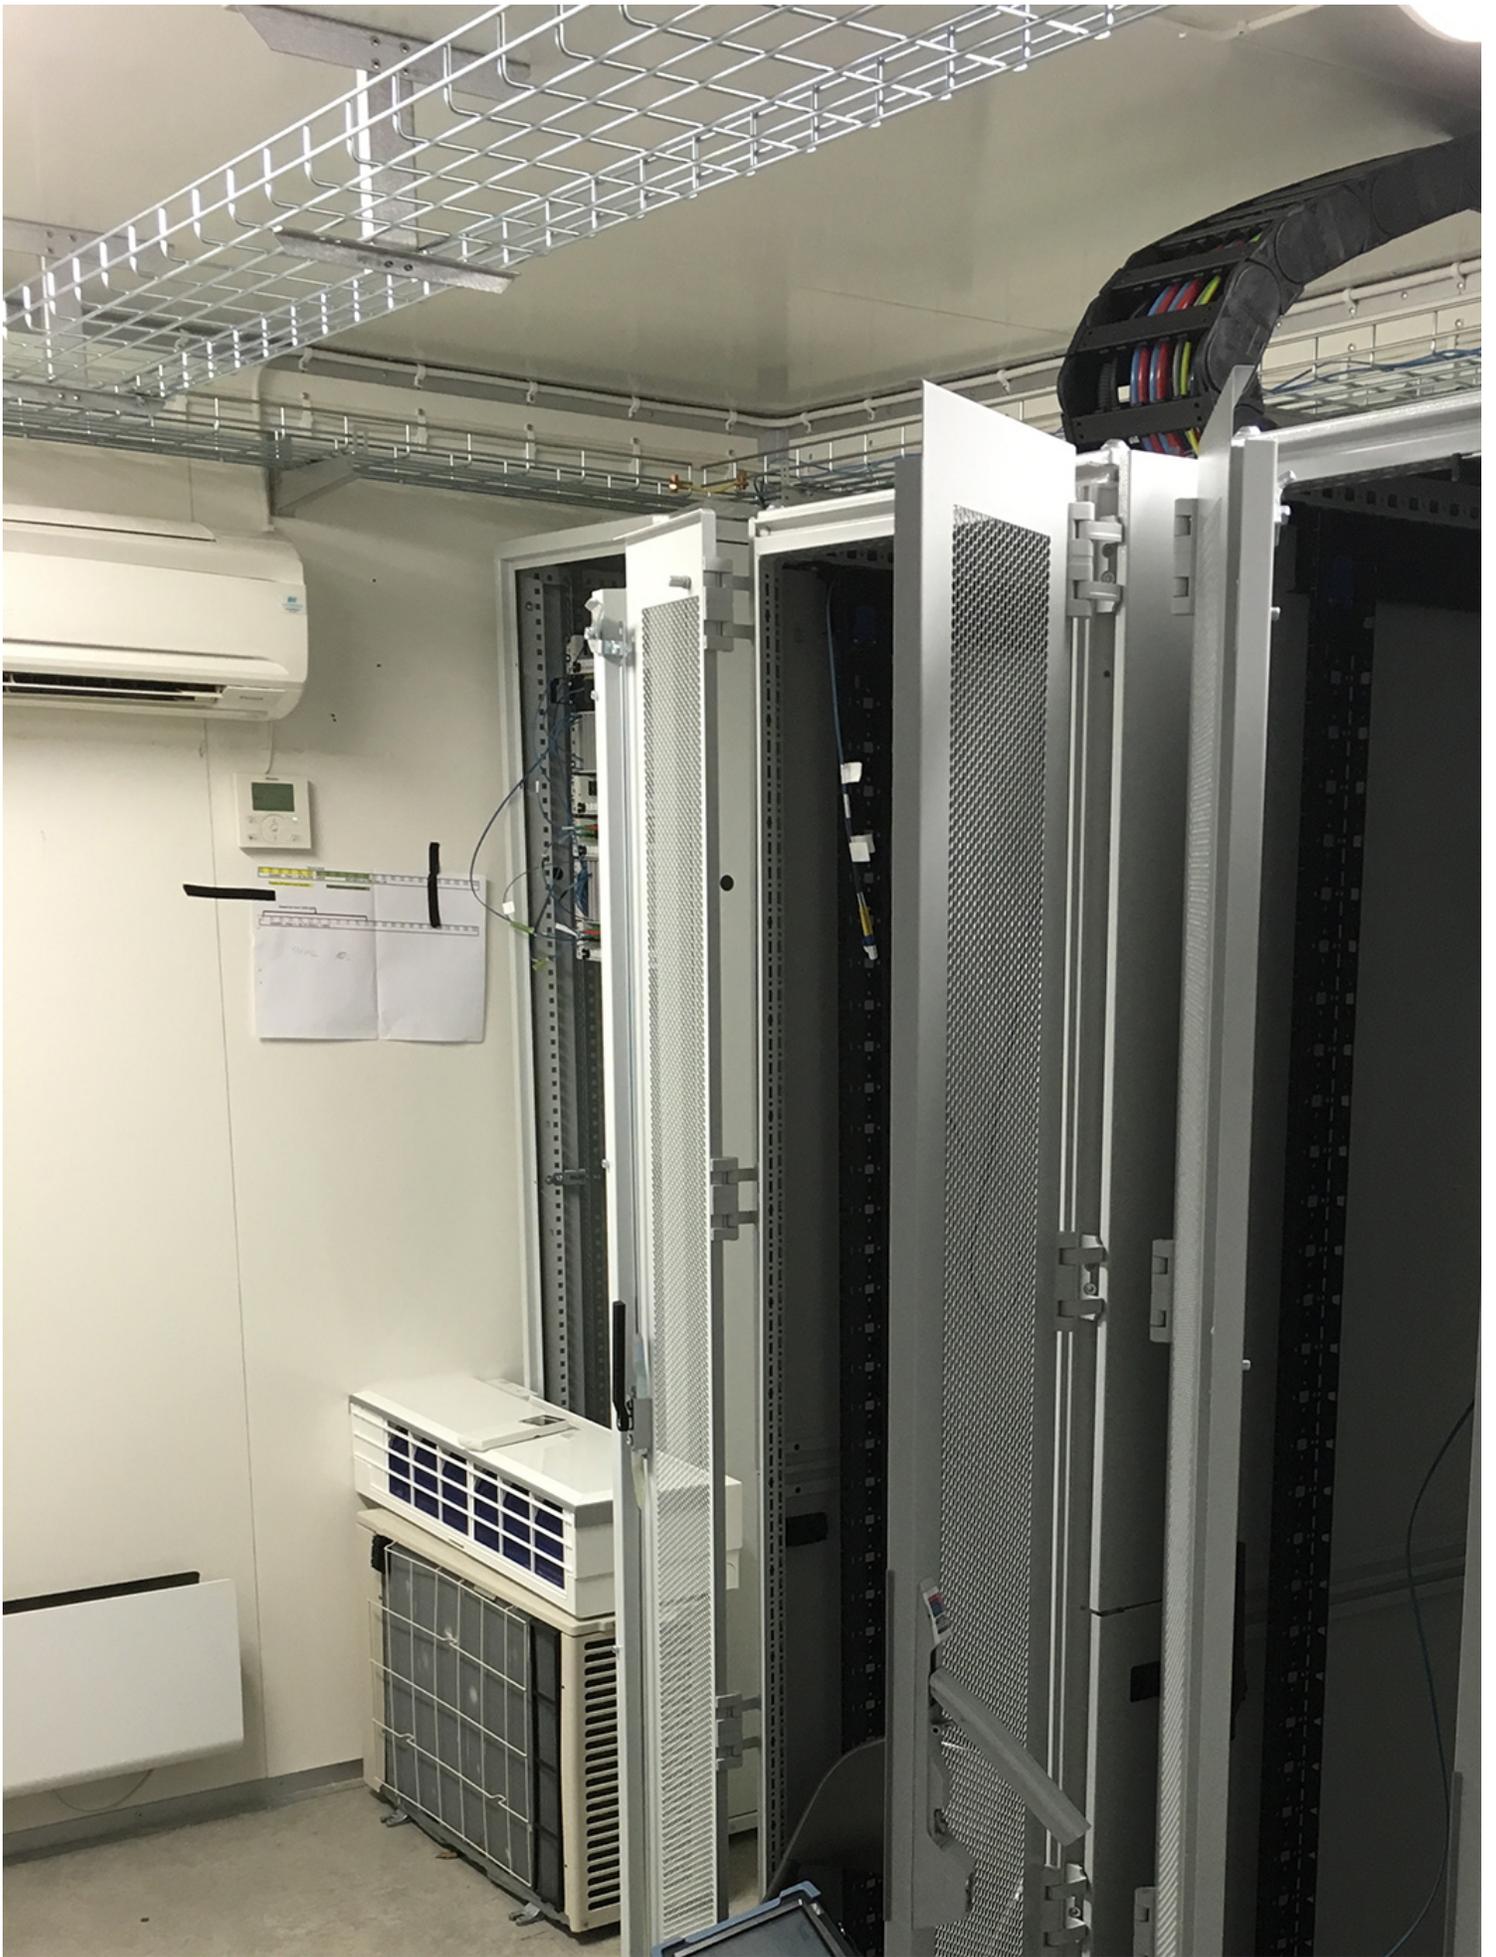
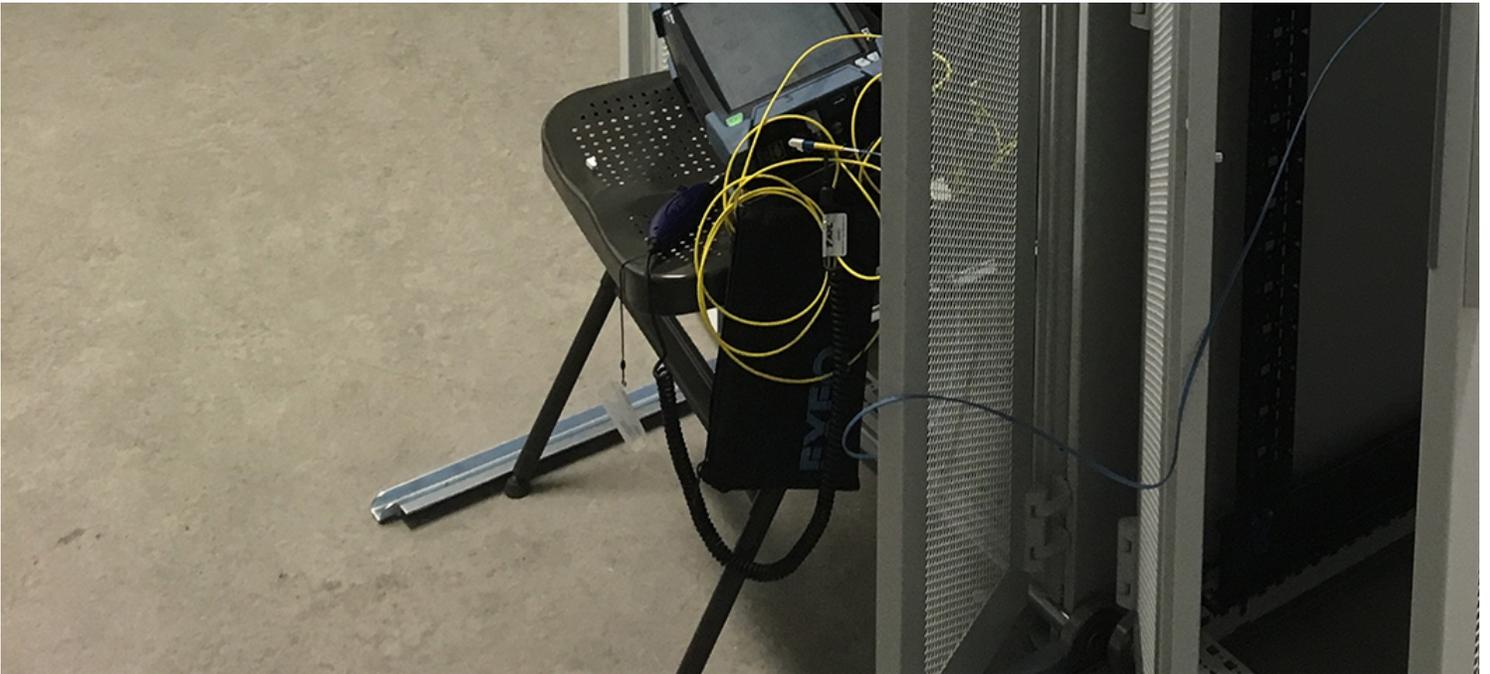
Most of our fiberplant is being delivered through aerial fiber hanging in the powerlines in the Swedish grid, this means that substations and powerplants is natural breakingpoints where a amplifier or a drop-site could be placed.

In Gävle we will place routers and drop wavelengths to HIG (Högskolan i Gävle) so the core on wheels so we can get behind the racks.

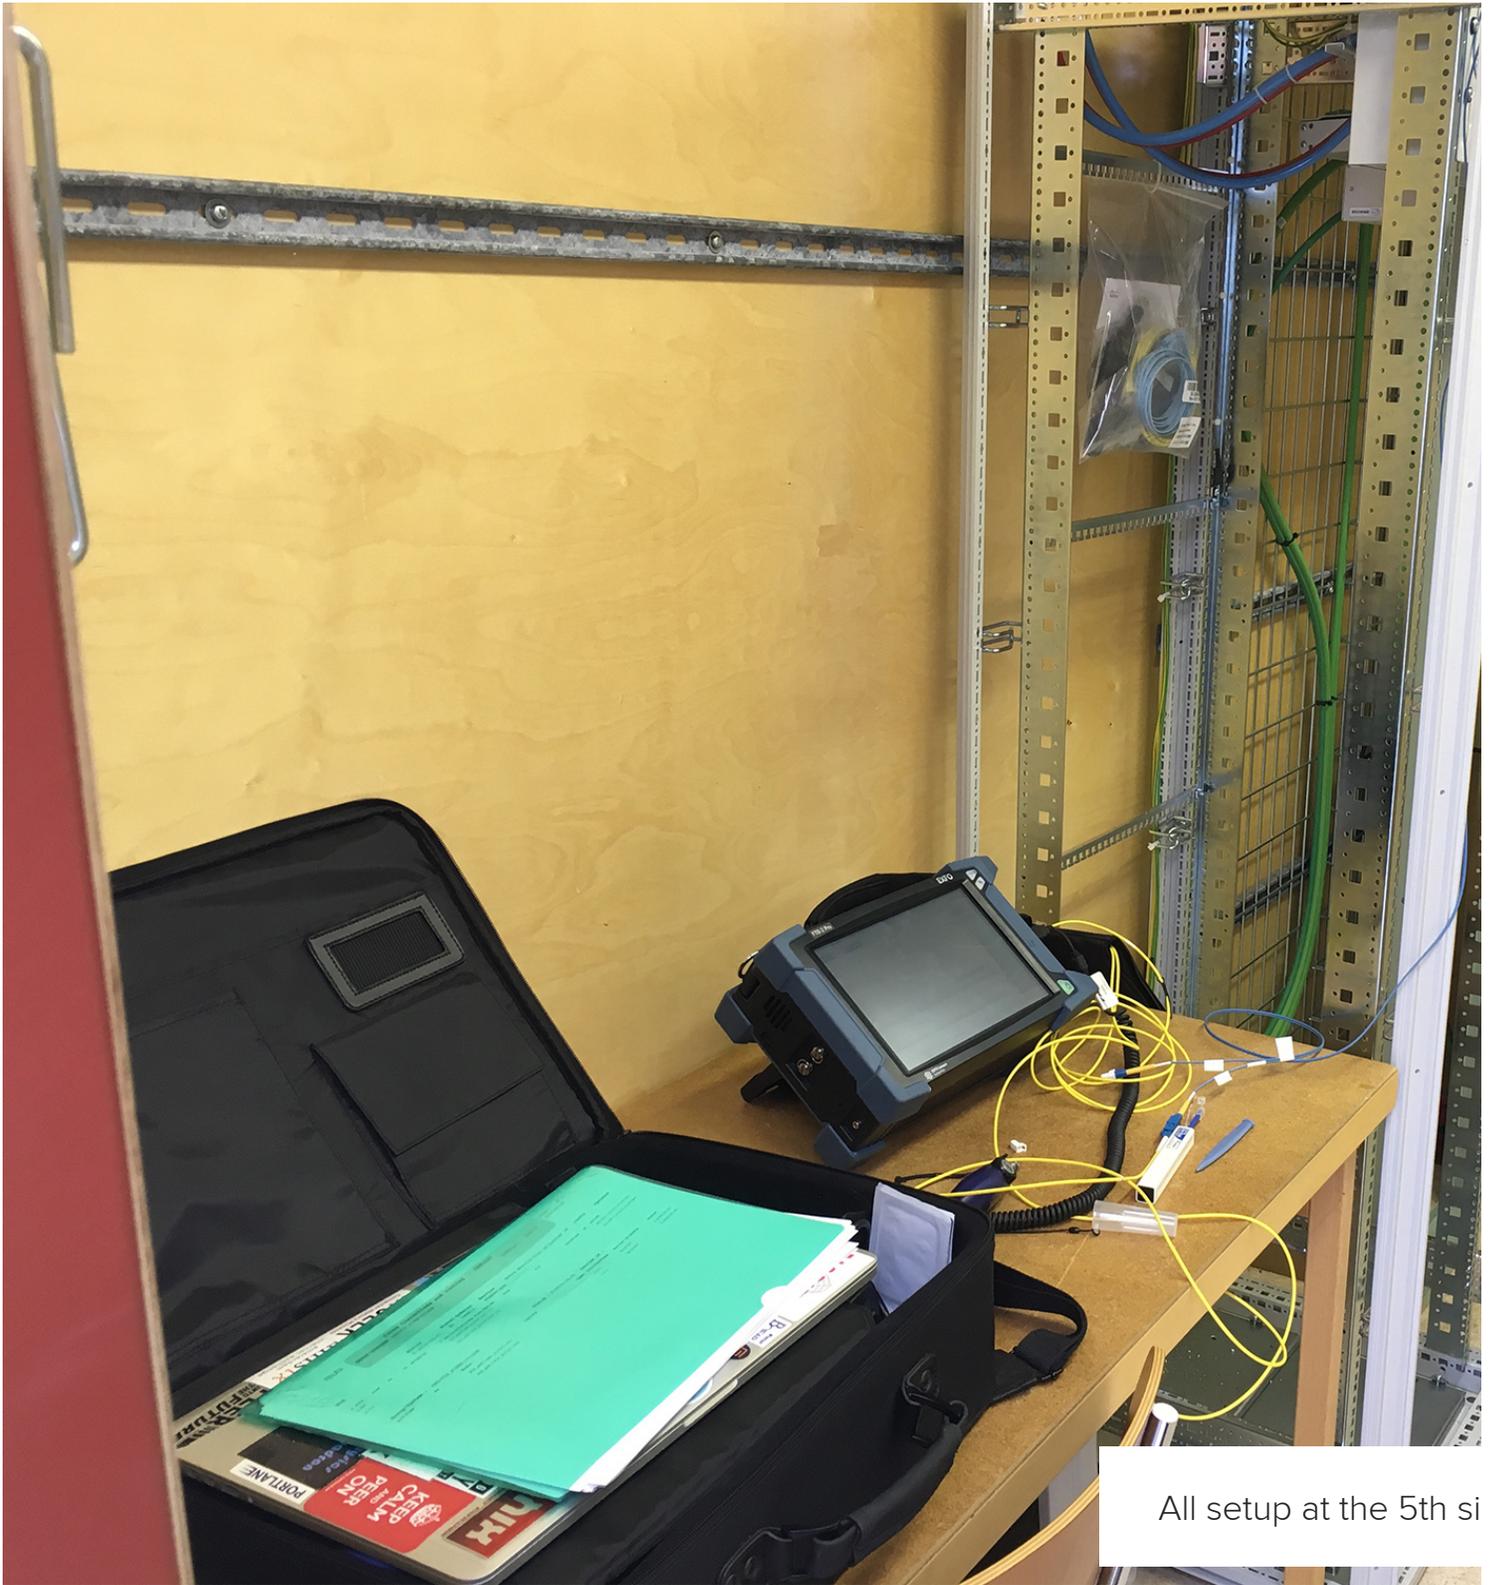
For the first day i managed to squeeze in all 7 sites between Stockholm and Sundsvall.

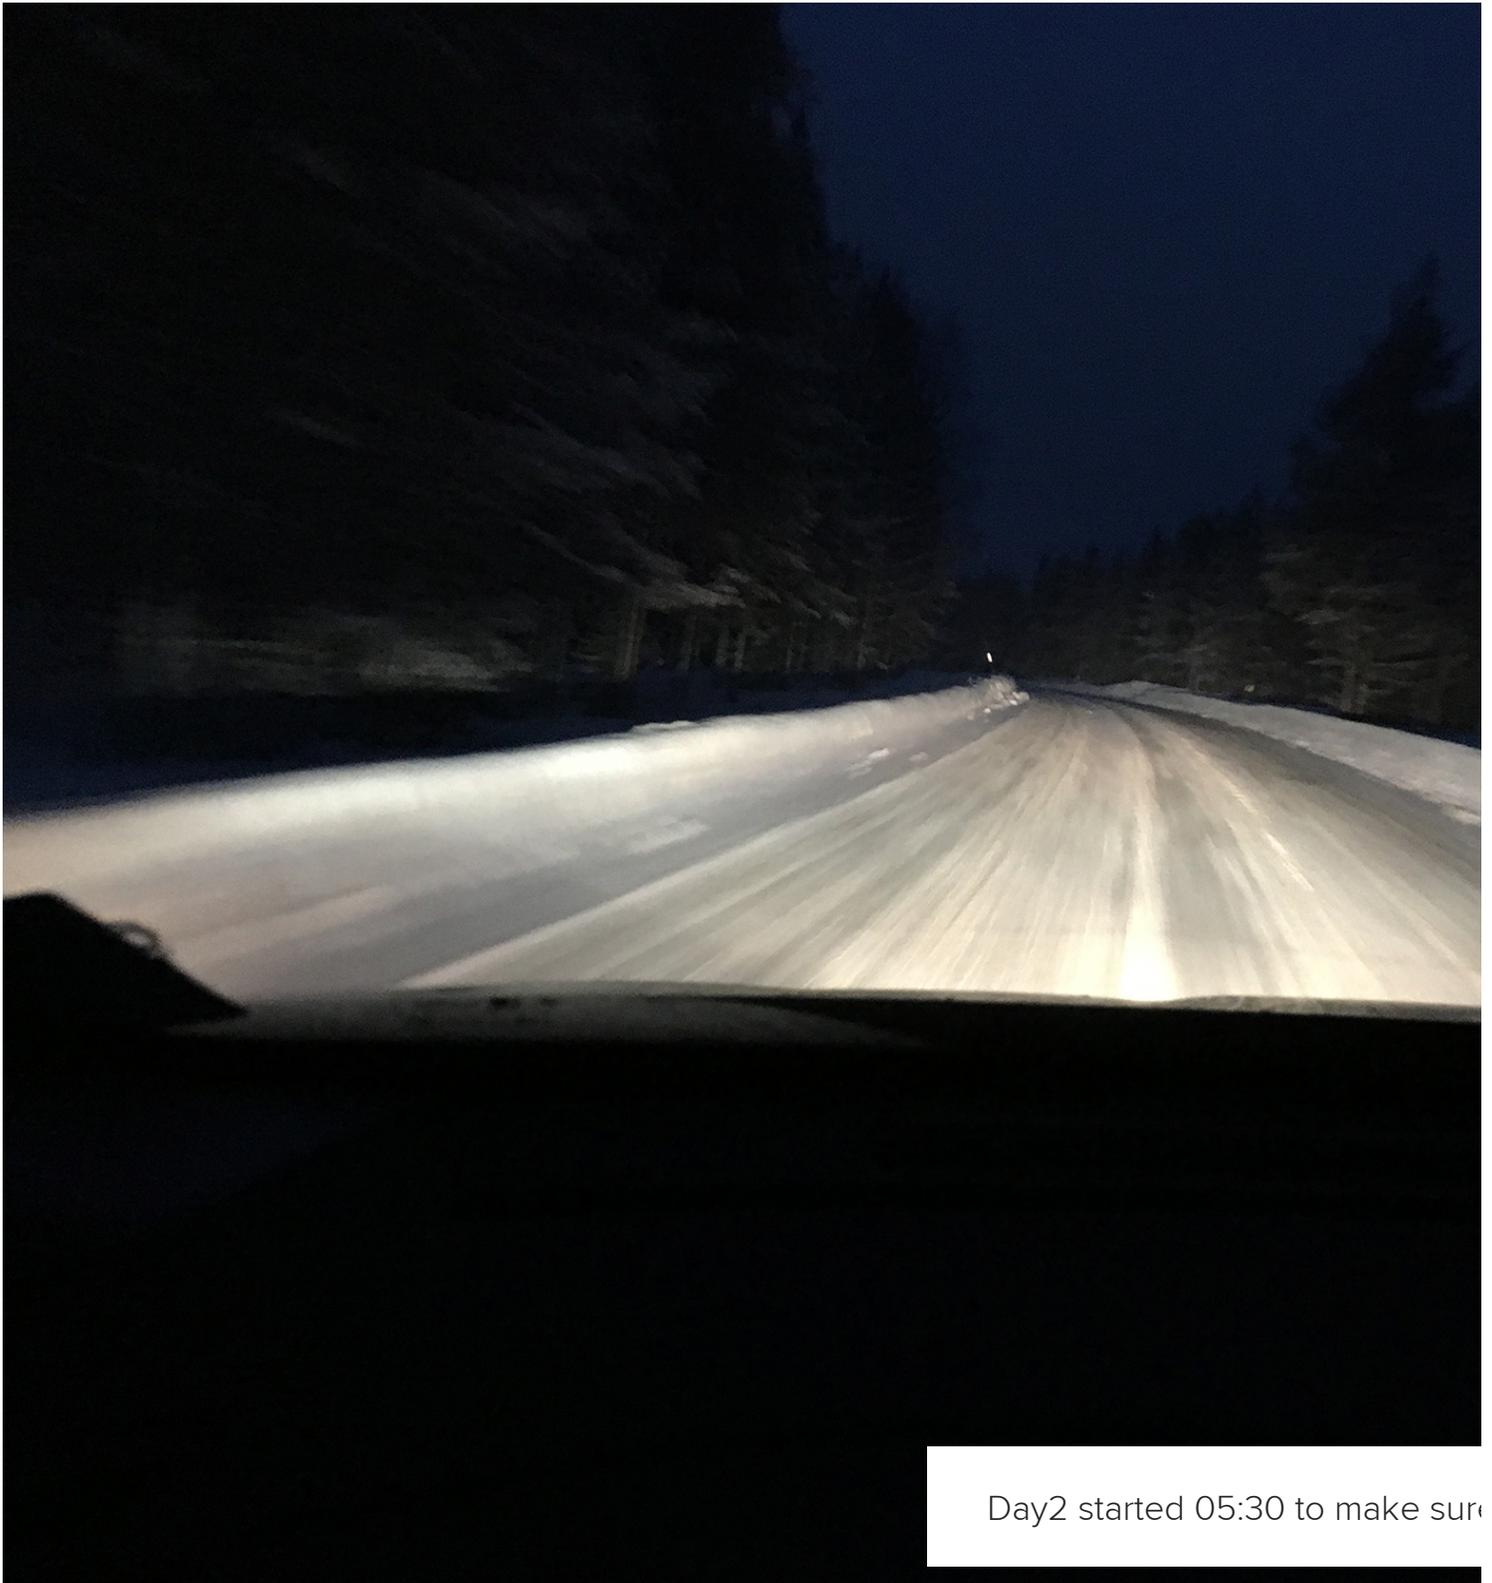
Day 2 i headed out from Sundsvall and headed inwards the country and north, passing two power-stations north of Östersund to finish off in Östersund and take a flight back home.

Day2 started 05:30 to make sure
